INSTALLATION RESTORATION PROGRAM

CLOSURE ASSESSMENT REPORT FOR UST REMOVALS AT SITES 4 AND 5 - PETROLEUM, OILS, AND LUBRICANTS FACILITY

VIRGINIA AIR NATIONAL GUARD 192nd FIGHTER GROUP RICHMOND INTERNATIONAL AIRPORT SANDSTON, VIRGINIA

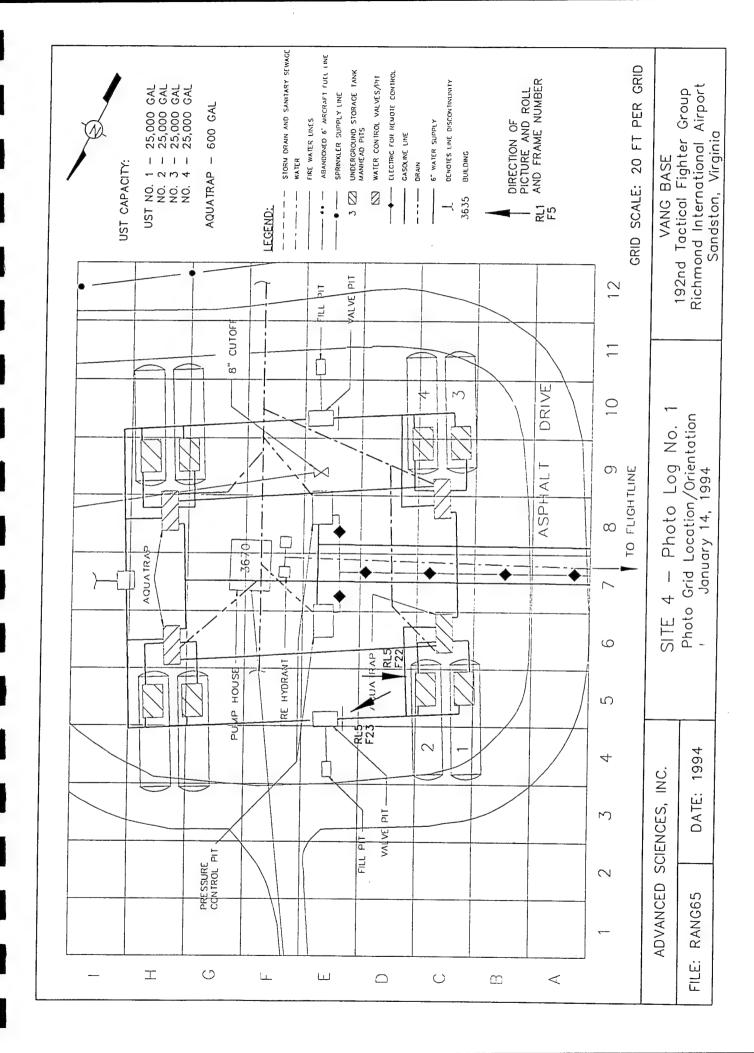
SUBJECT/DESCRIPTION	REFUELING OPERATIONS IN ACTIVE PORTION OF POL; VIEW TO THE NE.	EXCAVATION OF UST No. 2; VIEW TO THE SW.
FRAME NEGATIVE No. No.	55	21
FRAME No.	23	22
ROLL No.	က	ß
DATE	94/01/14	94/01/14
PHOTO LOG No.	-	-
SITE	4	4

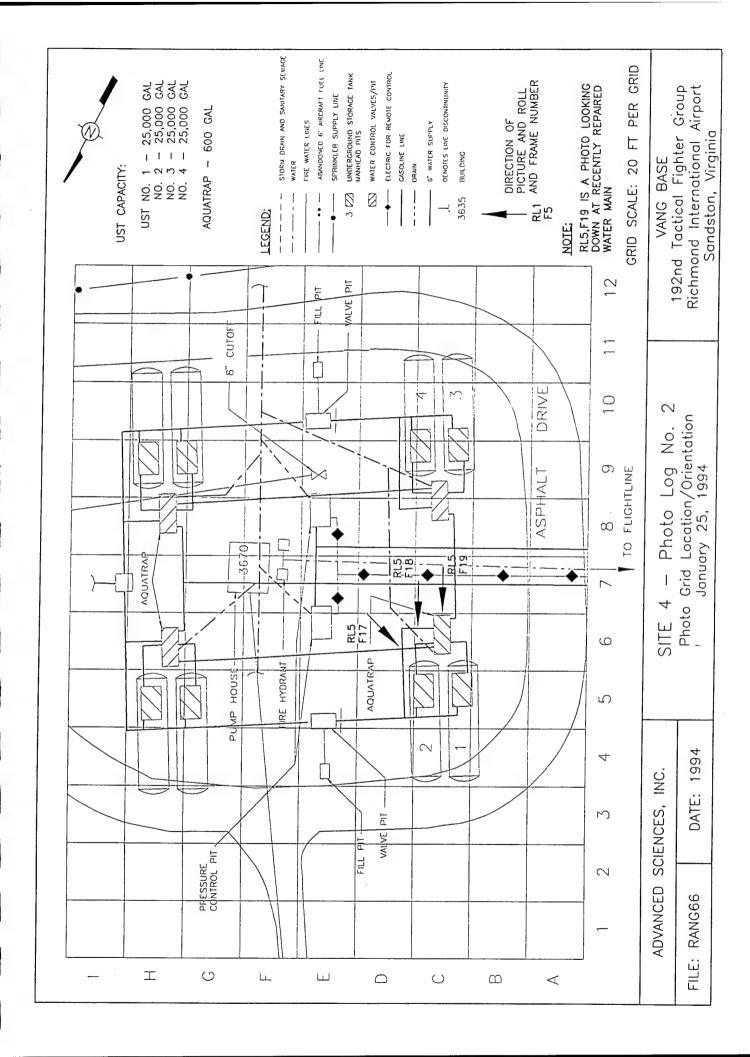
SUBJECT/DESCRIPTION	VIEW INTO PIT AROUND CONCRETE MANWAY FOR UST No. 2;	UST No. 2 REMOVAL; VIEW TO THE NW.	UST No. 2 REMOVAL; VIEW TO THE WEST
FRAME NEGATIVE No. No.	18 V		t6 D
FRAME No.	19	18	- 12
ROLL No.	ĸ	43	ध्य
DATE	94/01/25	94/01/25	94/01/25
PHOTO LOG No.	2	Ç4	cy.
SITE	4	P	ş

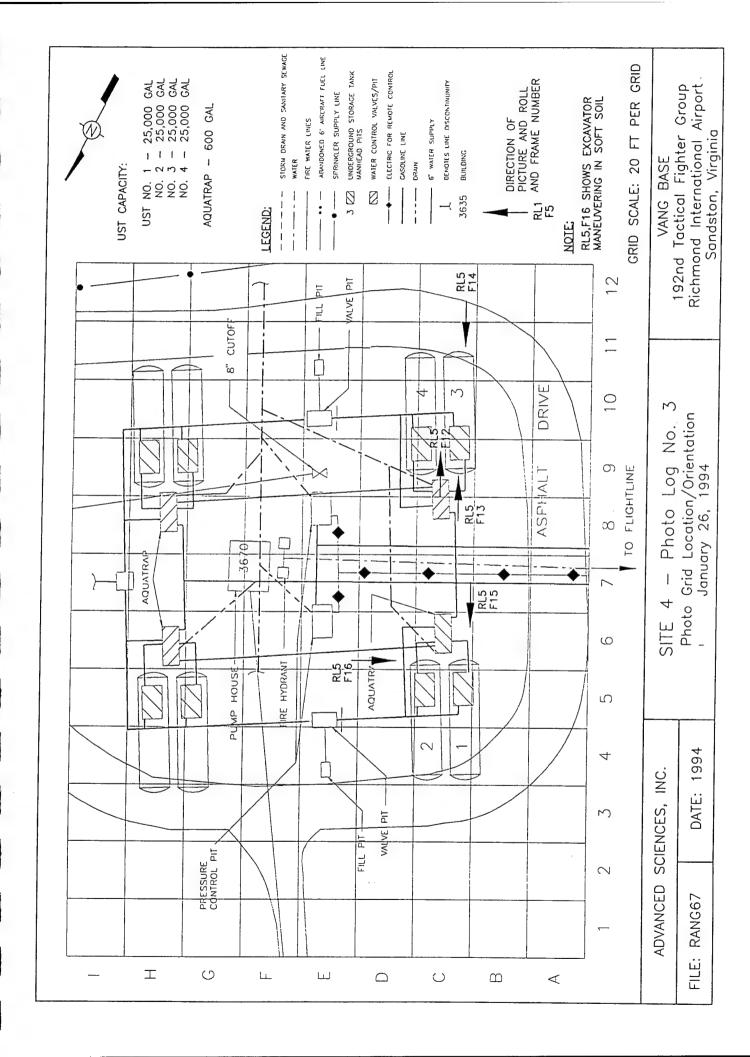
SUBJECT/DESCRIPTION	EXCAVATION OF UST No. 2; VIEW TO THE SW.	EXCAVATION OF UST No. 2; VIEW TO THE NW.	EXCAVATION OF UST No. 3; VIEW TO THE NW.	EXCAVATION OF UST No. 3; VIEW TO THE SE.	EXCAVATION OF UST No. 3; VIEW TO THE SE.
FRAME NEGATIVE No. No.	15	41	13	12	£
FRAME No.	16	15	14	13	12
ROLL No.	ro	Ŋ	ស	ro	ß
DATE	94/01/26	94/01/26	94/01/26	94/01/26	94/01/26
PHOTO LOG No.	ო	ო	ო	ო	თ
SITE	4	4	4	4	4

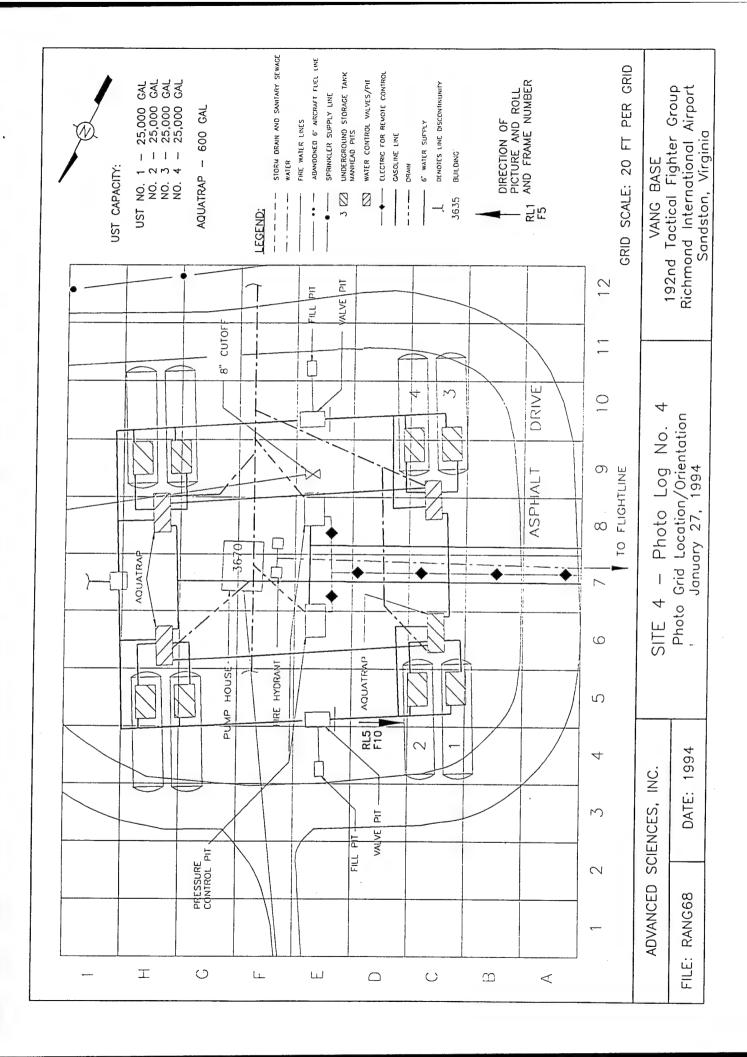
SUBJECT/DESCRIPTION	UST No. 2 REMOVAL; VIEW TO THE SW.
NEGATIVE No.	6
FRAME No.	10
ROLL No.	ro
DATE	94/01/27
PHOTO LOG No.	4
SITE	4

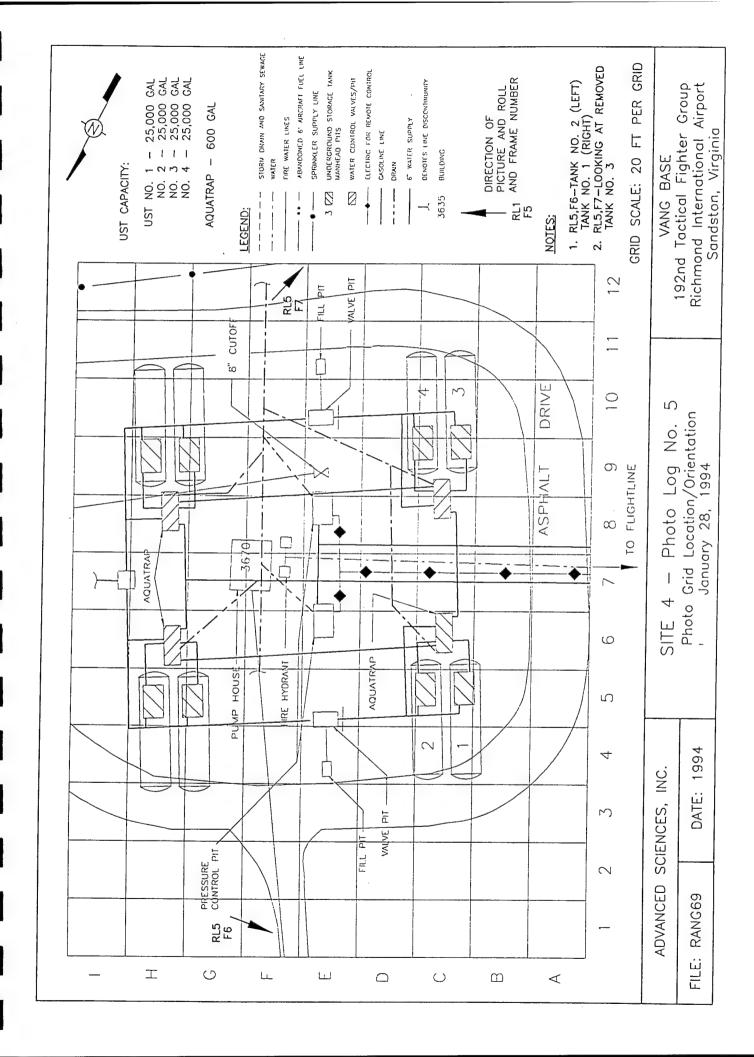
SUBJECT/DESCRIPTION	6 UST No. 3 IN TEMPORARY STORAGE AREA, VIEW OT THE SW.	5 UST Nos. 1.8.2 IN TEMPORARY STORAGE AREA, VIEW TO THE WEST.
FRAME NEGATIVE No. No.	<i>6</i>	5 C
FRAME No.		9
ROLL No.	чs	42
DATE	94/01/28	94/01/28
PHOTO LOG No.	ĝ	\$
SITE	Ą	¥

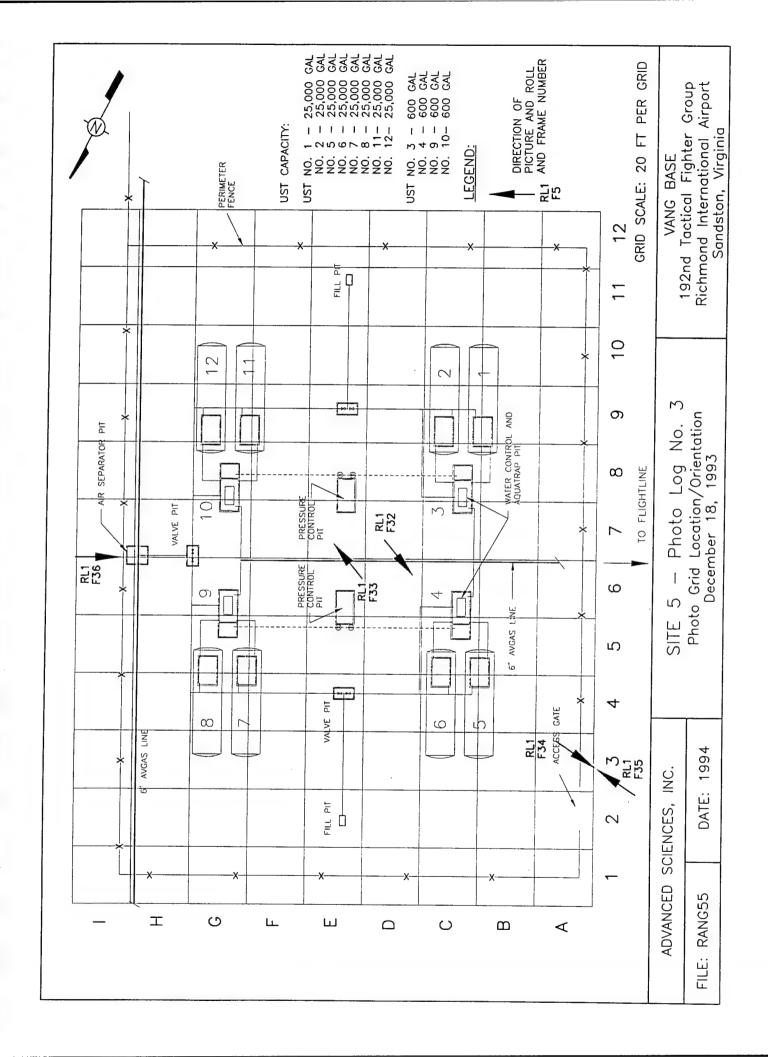
SUBJECT/DESCRIPTION	VIEW TO WEST ACCESS ROAD COMING INTO POL; INITIAL PUMPING OPERATIONS RELATED TO UST No. 12.	VIEW TO THE EAST ACROSS POL FOR PUMPING FROM UST No. 12.	VIEW TO THE WEST ACCESS ROAD AND TANKER BEING LOADED.	VIEW TO THE EAST OF GRUBBED POL AND LINES FOR PUMPING.	AIR SEPARATOR PIT AND GRUBBED SITE; VIEW TO THE SW.
FRAME NEGATIVE No. No.	33/33A V	34/34A \	35/35A V	36/36A \	ш
FRAME No.	32	33	34	35	36
ROLL No.	-	-		-	-
DATE	93/12/18	93/12/18	93/12/18	93/12/18	93/12/18
PHOTO DATE LOG No.	ო	m	ო	m	ო
SITE	ß	S	ιo	ĸ	ro

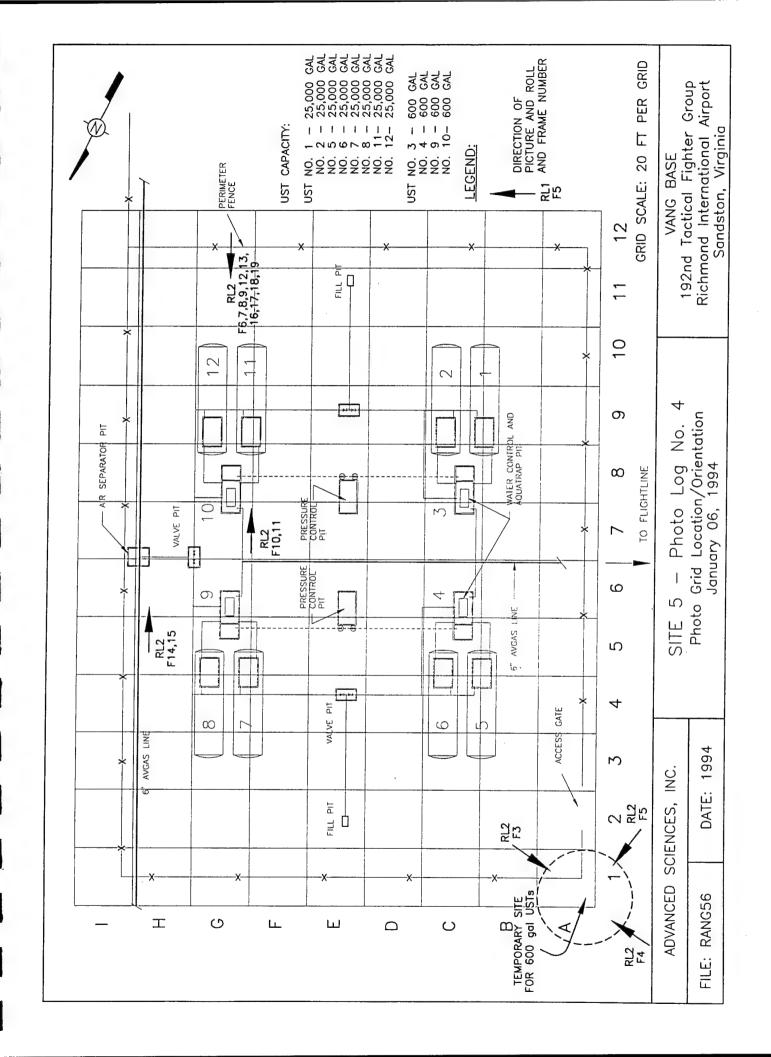
SUBJECT/DESCRIPTION	EXCAVATING UST No. 11/12; VIEW TO THE NW.	EXCAVATING UST No. 11/12; VIEW TO THE NW.	REMOVAL OF AIR SEPARATOR PIT EQUIPMENT; VIEW TO THE SE.	REMOVAL OF AIR SEPARATOR PIT EQUIPMENT; VIEW TO THE SE.	REMOVAL OF UST No. 12; VIEW TO THE NW.	REMOVAL OF UST No. 12; NOTE MINIMAL WATER IN PIT BOTTOM; VIEW TO THE NW.	HEMOVAL OF UST NG. (2) VIEW TO THE NW.	REMOVAL OF UST No. 12; VIEW TO THE NW.
NEGATIVE No.	13	4	15	16	17	8	19	50
FRAME No.	12	13	4	15	16	17	18	6
ROLL No.	8	8	8	8	8	61	2	2
DATE	94/01/06	94/01/06	94/01/06	94/01/06	94/01/06	94/01/06	90/1076	94/01/06
PHOTO LOG No.	4	4	4	4	4	4	4	4
SITE	Ŋ	S	ည	S	S	Ŋ	5	ro.

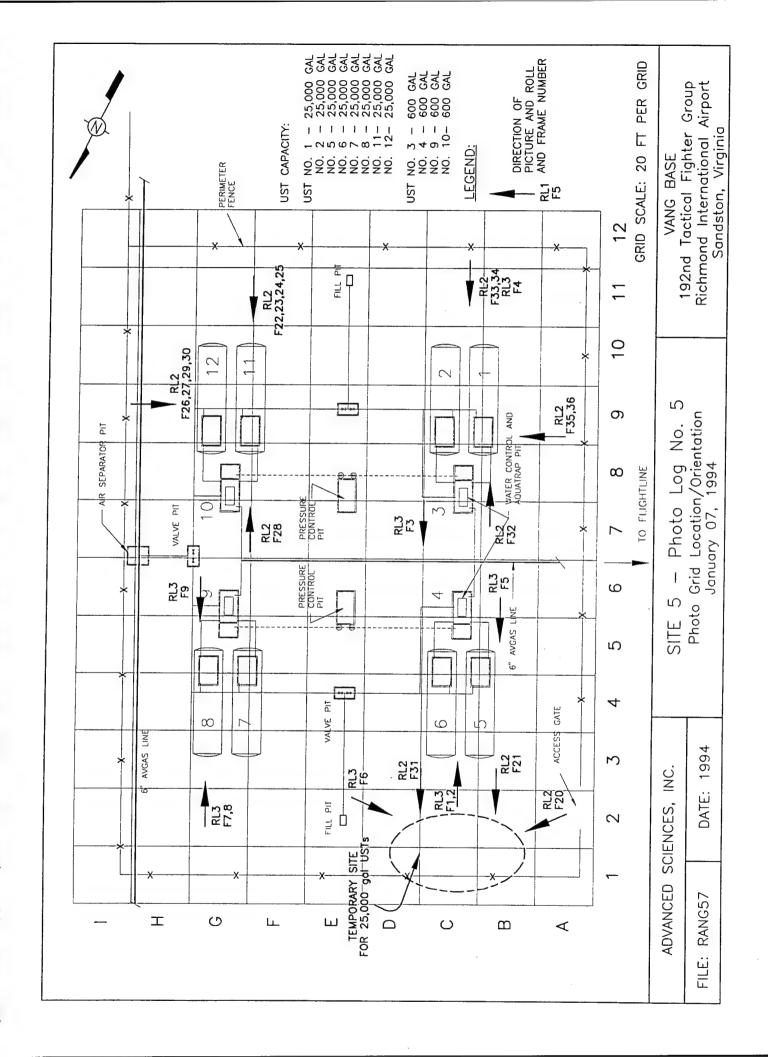
SUBJECT/DESCRIPTION	REMOVAL OF UST No. 11; VIEW TO THE SW.	REMOVAL OF UST No. 11; VIEW TO THE SW.	UST Nos. 11 & 12 IN TEMPORARY STORAGE; VIEW TO THE NW.	EXCAVATION OF UST No. 1; VIEW TO SE.	EXCAVATION OF UST No. 1; VIEW TO NW.	EXCAVATION OF UST No. 1; VIEW TO NW.	EXCAVATION OF UST No. 1; VIEW TO NE.	EXCAVATION OF UST No. 1; VIEW TO NE.	UST No. 1 REMOVAL; VIEW TO THE SE.
NEGATIVE No.	30	31	32	33	8	32	36	END	Ø
FRAME No.	59	30	31	32	33	34	35	36	-
ROLL No.	8	N	Ø	8	α	2	Ø	2	ო
DATE	94/01/07	94/01/07	94/01/07	94/01/07	94/01/07	94/01/07	94/01/07	94/01/07	94/01/07
PHOTO LOG No.	SO.	ស	го	រេ	ιo	ıo	ю	ισ	ĸ
SITE	જ	Ŋ	2	Ŋ	വ	ည	Ŋ	Ľ	Ŋ

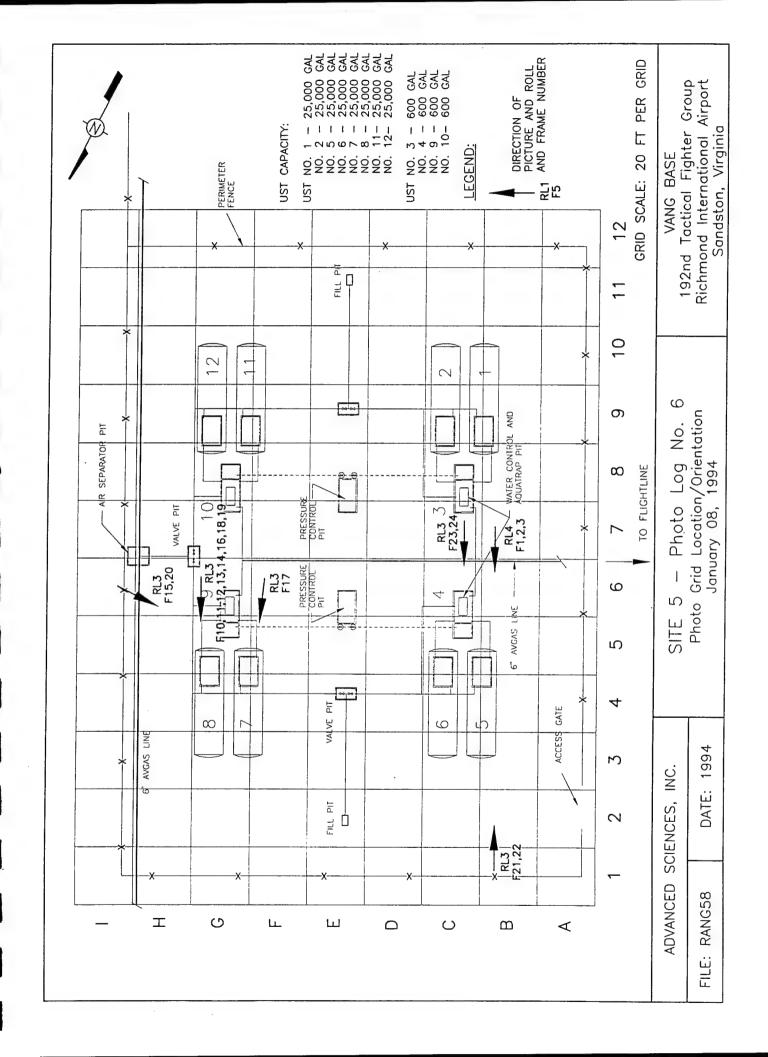
SUBJECT/DESCRIPTION	REMOVAL OF UST No. 7; VIEW TO THE NW.	USTs IN TEMPORARY STORAGE; VIEW TO THE W.	EXCAVATION OF UST No. 5; VIEW TO THE SE.	EXCAVATION OF UST No. 5; VIEW TO THE SE.	EXCAVATION OF UST No. 5; VIEW TO THE NW.	EXCAVATION OF UST No. 5; VIEW TO THE NW.	REMOVAL OF UST No. 5; VIEW TO THE NW	REMOVAL OF UST No. 5; VIEW TO THE NW	REMOVAL OF UST No. 5; VIEW TO THE NW
NEGATIVE No.	50	21	55	23	24	END	8	ო	4
FRAME No.	61	20	21	55	23	24	-	Ø	ო
ROLL No.	ო	ო	ო	ო	ო	ო	4	4	4
DATE	94/01/08	94/01/08	94/01/08	94/01/08	94/01/08	94/01/08	94/01/08	94/01/08	94/01/08
PHOTO LOG No.	9	9	မ	ဖ	ဖ	ဖ	ဖ	စ	9
SITE	ro	ည	S	Ŋ	S	Ŋ	S	S	2

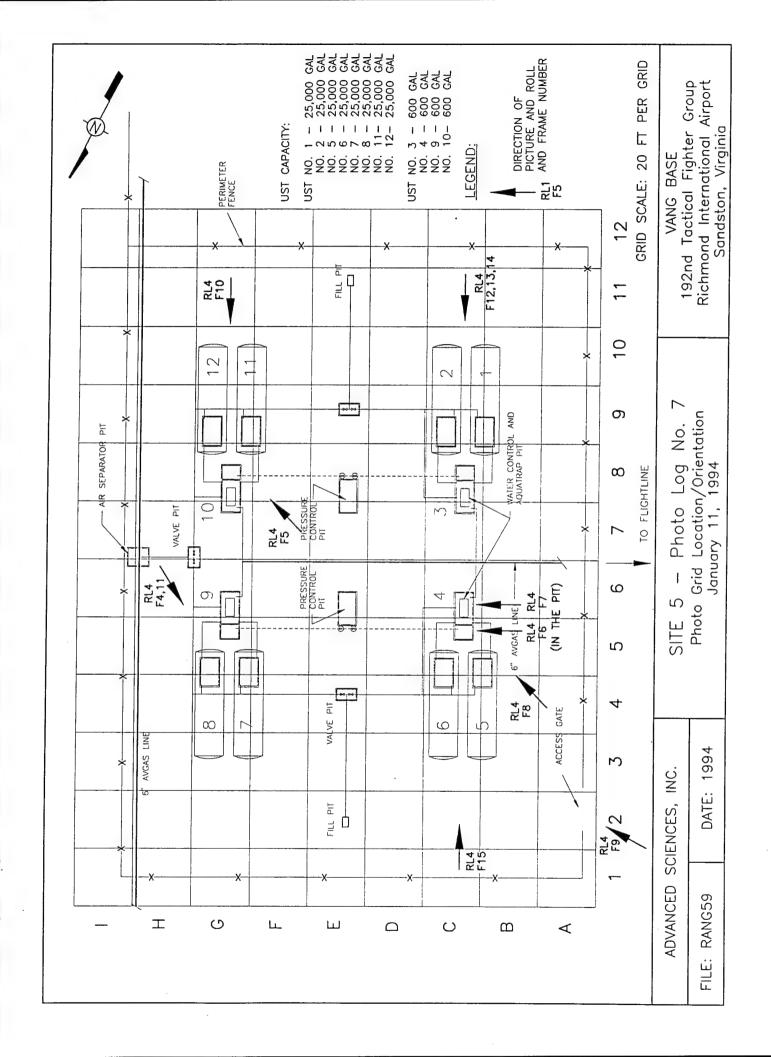
SUBJECT/DESCRIPTION	EXCAVATED PIT FROM REMOVAL OF UST No. 1; VIEW TO THE NW.	EXCAVATED PIT FROM REMOVAL OF UST No. 1; VIEW TO THE NW.	EXCAVATED PIT FROM REMOVAL OF UST No. 1; VIEW TO THE NW.	EXCAVATED PIT FROM REMOVAL OF UST No. 5; VIEW TO THE SE.
FRAME NEGATIVE No. No.	13	4	15	16
FRAME No.	12	13	4	5
ROLL No.	4	4	4	4
DATE	94/01/11	94/01/11	94/01/11	94/01/11
PHOTO LOG No.	7	7	7	7
SITE	ល	Ŋ	2	ĸ

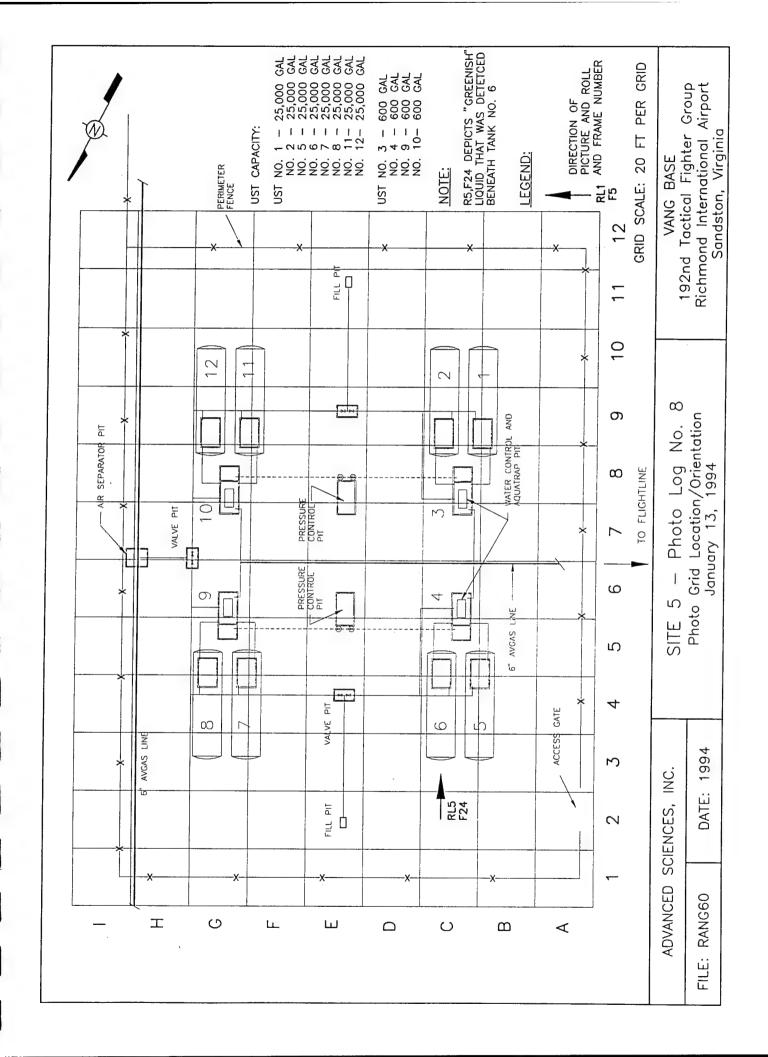
SUBJECT/DESCRIPTION	BOTTOM OF TANK PIT FOR UST No. 6; VIEW TO THE SE.
FRAME NEGATIVE No. No.	23
FRAME No.	24
ROLL No.	ĸ
DATE	94/01/13
PHOTO LOG No.	œ
SITE	S.

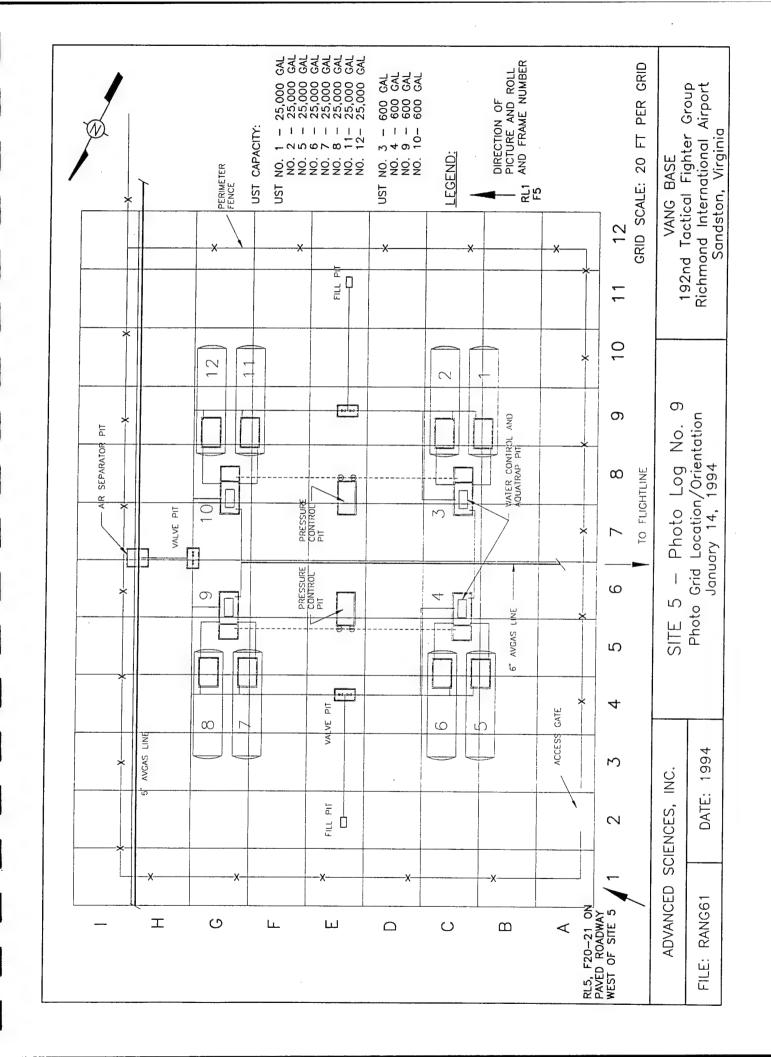
SUBJECT/DESCRIPTION	EQUIPMENT ON PAVED ROAD ADJACENT TO SITE 5; VIEW TO THE E.	EQUIPMENT ON PAVED ROAD ADJACENT TO SITE 5; VIEW TO THE NW.
FRAME NEGATIVE No. No.	50	19
FRAME No.	22	20
ROLL No.	ß	ĸ
DATE	94/01/14	94/01/14
PHOTO LOG No.	თ	თ
SITE	Ŋ	2

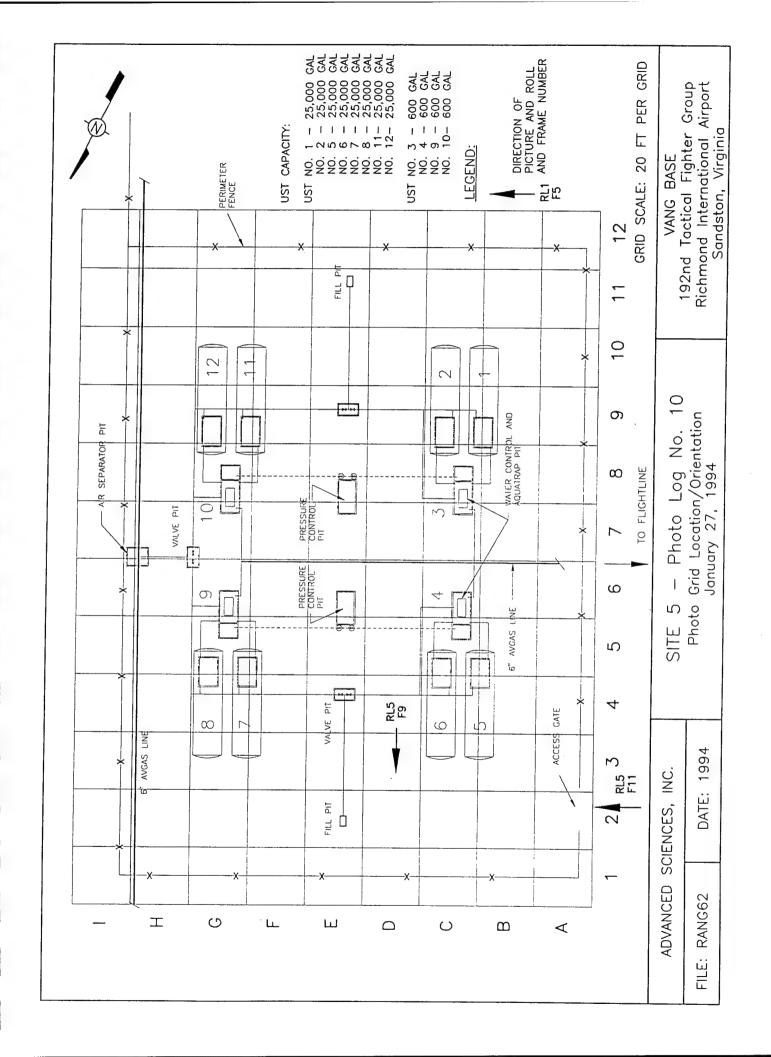
SUBJECT/DESCRIPTION	VIEW FROM ACCESS ROAD INTO POL; VIEW TO THE EAST	USTs BEING DESTROYED; VIEW TO THE NW.
FRAME NEGATIVE No. No.	10	60
FRAME No.	=	თ
ROLL No.	S	ro
DATE	94/01/27	94/01/27
PHOTO LOG No.	9	10
SITE	ഹ	rc

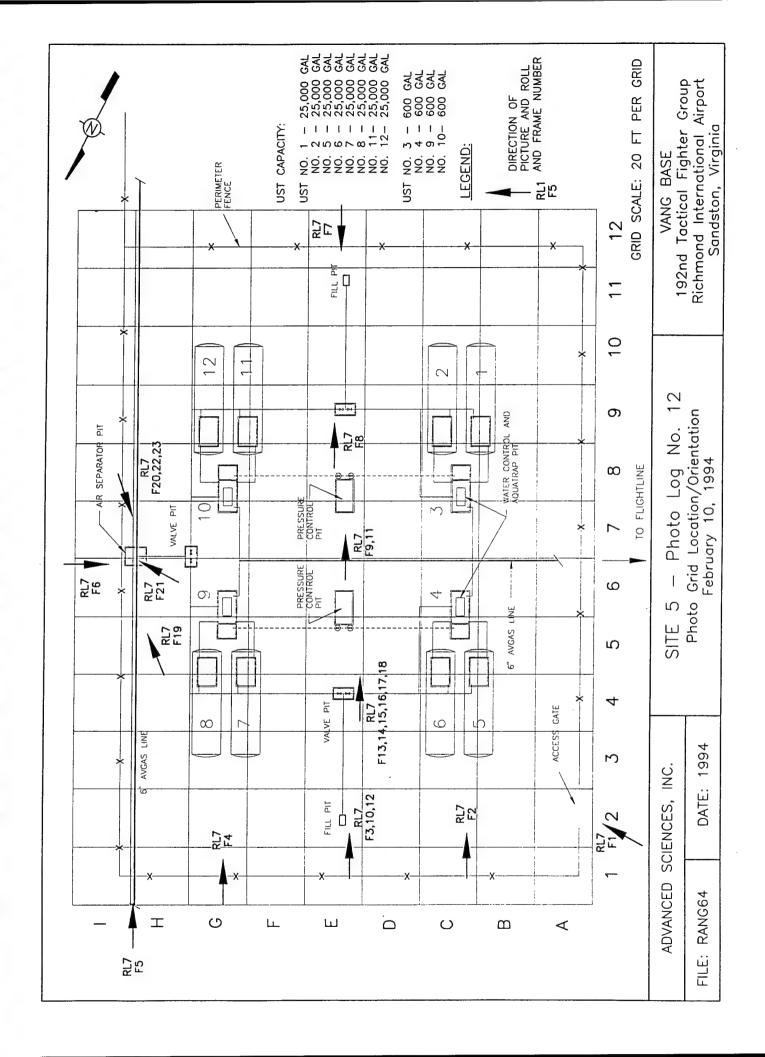
SUBJECT/DESCRIPTION	CONCRETE PRESSURE CONTROL BOX REMOVAL; VIEW TO THE SE.	CONCRETE AIR SEPARATOR BOX REMOVAL; VIEW TO THE SE.	CONCRETE AIR SEPARATOR BOX REMOVAL; VIEW TO THE NW.	CONCRETE AIR SEPARATOR BOX REMOVAL; VIEW INTO THE PIT.	CONCRETE AIR SEPARATOR BOX REMOVAL; VIEW INTO THE PIT.	CONCRETE AIR SEPARATOR BOX REMOVAL; VIEW INTO THE PIT.
WE	Ö	Ö	Ö	Ö	Ö	Ö
FRAME NEGATIVE No. No.	19	20	2	22	23	24
FRAME No.	81	19	50	24	22	23
ROLL No.	_	~	^	^	~	7
DATE	94/02/10	94/02/10	94/02/10	94/02/10	94/02/10	94/02/10
PHOTO LOG No.	5	5	2	5	5	12
SITE	ഹ	ĸ	ıo	S	ĸ	2

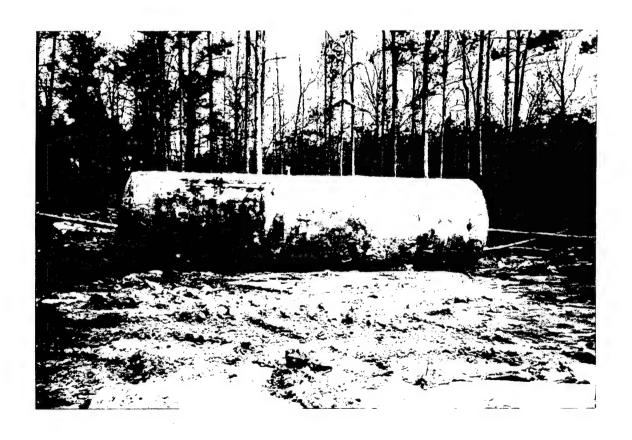
Site 5 - UST No. 12 Removal. View to the Northwest. (Photo Log No. 4; Roll No. 2/Frame No. 18)

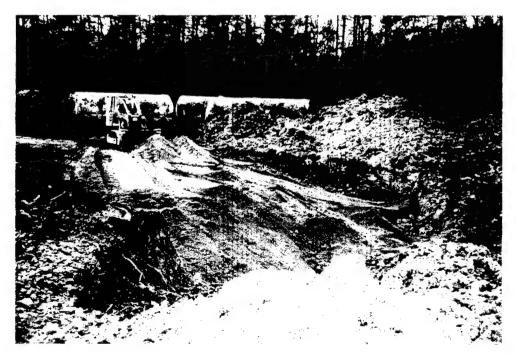
Site 5 - Backfill Operations, UST Nos. 7/8. View to the Northwest. (Photo Log No. 7; Roll No. 4/Frame No. 11)
